Infrared thermography for civil structural assessment: demonstrations with laboratory and field studies

Abstract A detailed investigation of infrared thermography (IRT) for civil structures is presented by considering different technologies, data analysis methods and experimental conditions in the laboratory and also in the field. Three different types of infrared (IR) camera were compared under active IRT conditions in the laboratory to examine the effect of photography angle on IRT along with the specifications of cameras. It is found that when IR images are taken from a certain angle, each camera shows different temperature readings. However, since each IR camera can capture temperature differences between sound and delaminated areas, they have a potential to detect delaminated area under a given condition in spite of camera specifications even when they are utilized from a certain angle. Furthermore, a more objective data analysis method than just comparing IR images was explored to assess IR data, and it is much easier to detect delamination

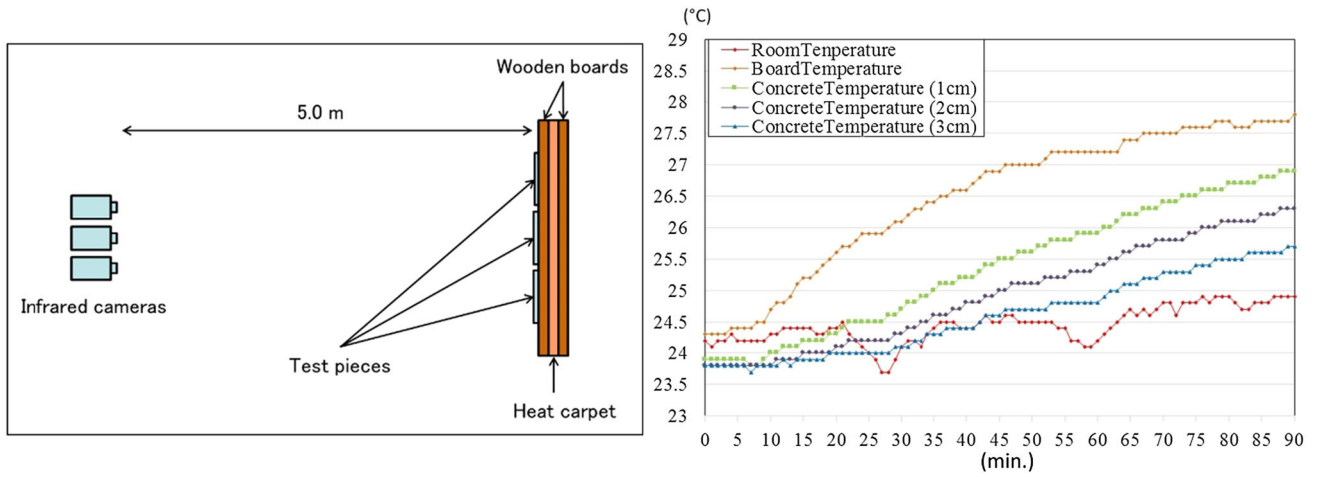
Fig. 5 Photography situation of Case 1 (left) and the temperature records (right)

Case 1 Photographing angle = 0° (Fig. 5)

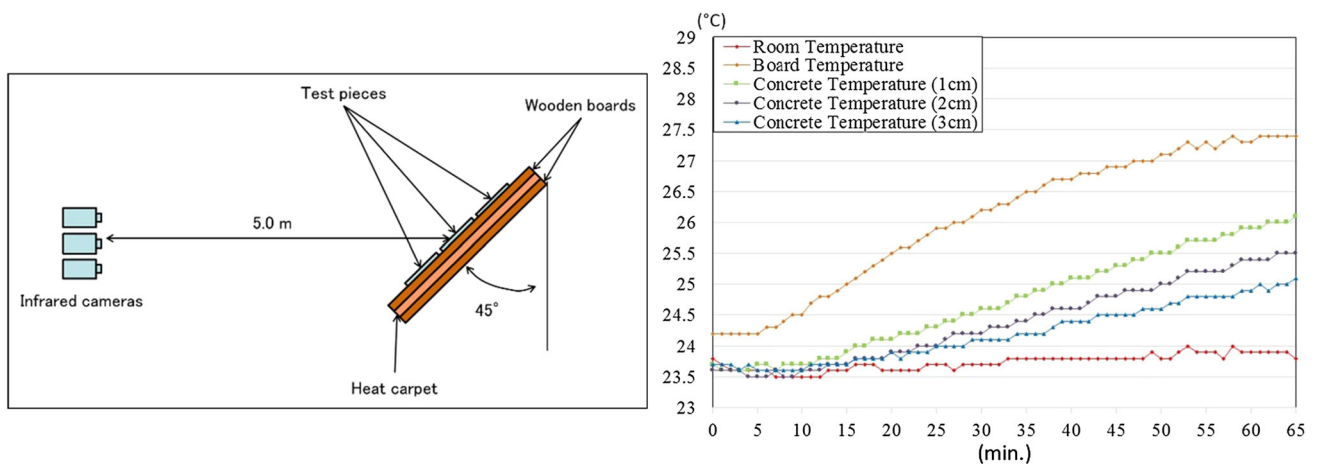
Fig. 7 Photography situation of Case 3 (left) and the temperature records (right)

Case 3 Photographing angle = 45° (Fig. 7)

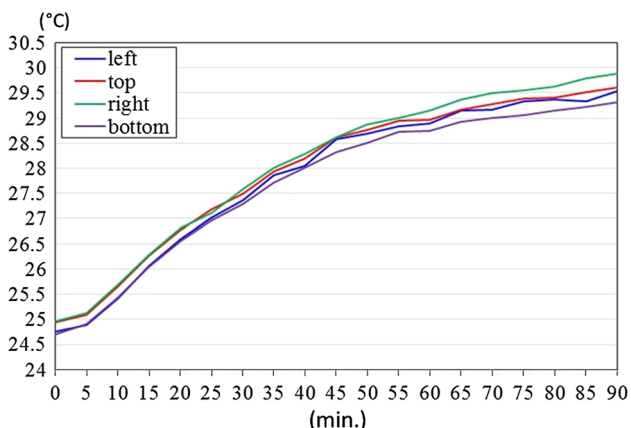
Fig. 9 Temperature readings at each point at each time

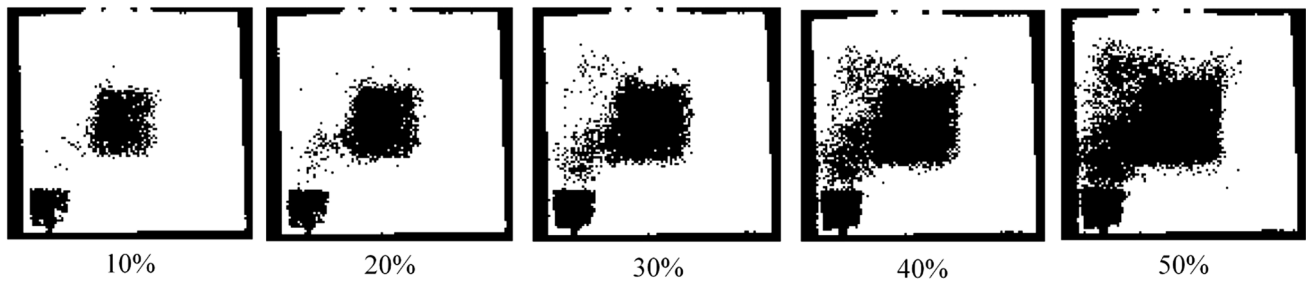
Fig. 24 Binary images (Case 1: SC5600, 75 min.)

where $G(x, y)$ is the value of each element of binarized image. Then, from these images, an image, which has relatively less noise and clearer delamination indication is chosen, 20 % was chosen in this case. This procedure is relatively subjective, yet this is a more objective way to judge a delaminated area than it is to decide it from raw IR images since the indication is displayed as black while the sound area is shown as white.

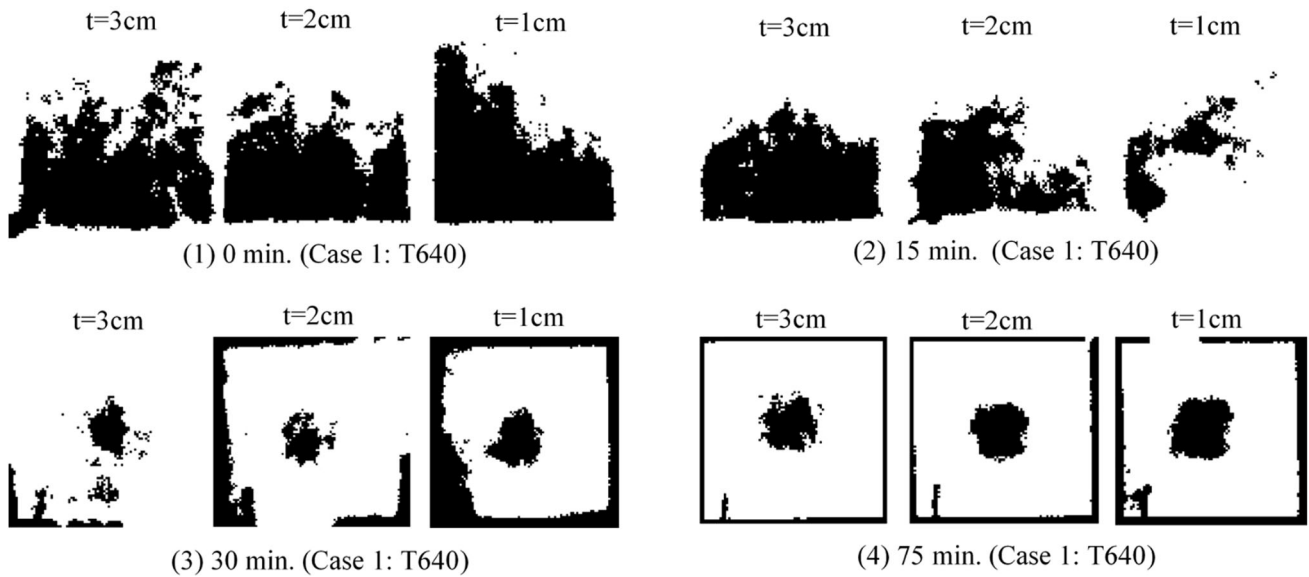
Fig. 26 Processed IR images taken at several times by T640 (Case 1)

Based on the methodology described in Sect. 5.1, each IR data shown in Figs. 17, 18, 19, 20 and 21 was processed as displayed in Figs. 25, 26, 27, 28 and 29, respectively. In terms of Case 1, photography angle = 0°, no camera can detect delamination at the beginning of the test as can be seen in (1) of each figure. After 15 min have elapsed, 1 and 2 cm images of SC5600 indicate something like a square

shape at the middle parts of the images; however, they also depict a lot of noise at the lower left. Still, SC5600 does not show any indication for 3 cm thick concrete plate at this time. T640 also indicates the sign of delamination at the middle area for 1 cm thick plate, although it also shows misdetection at the lower left. Regarding the other two thicknesses, T640 could not detect the delamination. In terms of T420, no indication can be recognized after 15 min. After 30 min have passed as exhibited in (3), both SC5600 and T640 point out delaminations for every thickness of test specimens with some noise, even though SC5600 draws more likely square shapes for each specimens. On the other hand, T420 depicts something like a square shape at the middle parts of the images of 1 and 2 cm thicknesses: however, it also shows a lot of noise at the left. At the point of 75 min later, every camera indicates delaminations on all test specimens at the middle areas with less noise. At this time, SC5600 also indicates more likely square shapes for each specimen than T640 and T420. When comparing T420 to the other two cameras, indications of T420 are much rougher than the others since

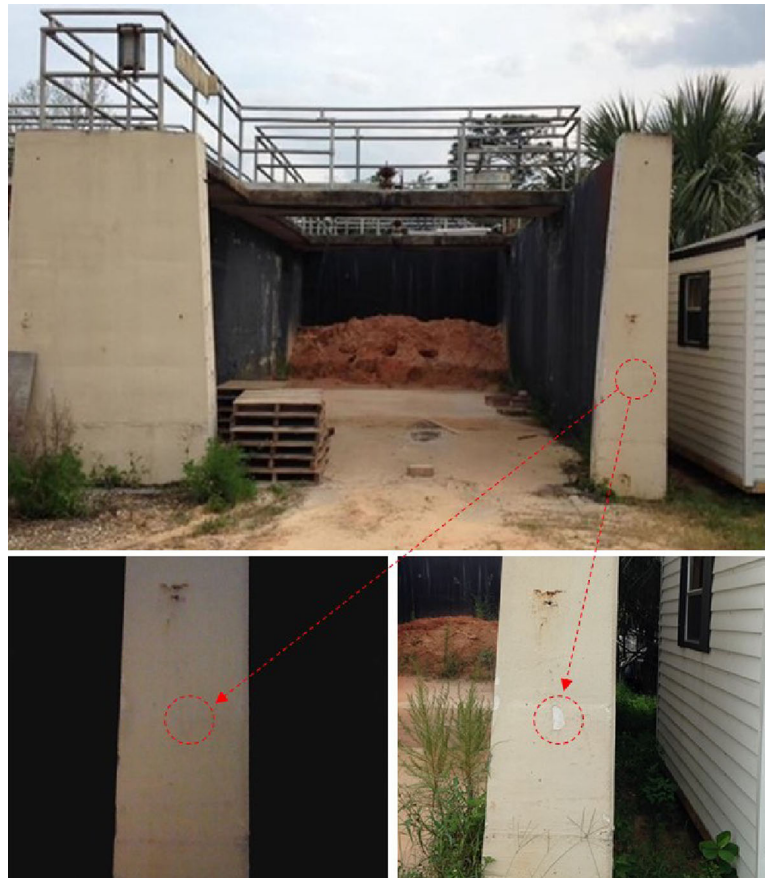
Fig. 30 Structure which delamination was found by IRT [upper the structure (used to be a water tank), lower left before hammering, lower right after hammering]

[24]. As displayed in Fig. 30, after the delamination was found by IRT, that location was hammered and a delaminated spot was revealed. In this study, the IR data collected by three cameras before hammering were used for the application of the data processing method. Figure 31 shows raw IR images in which the temperature spans were set up to recognize the delaminated area easily at the middle of the structure under the temperature range setting of 3.0 K. These IR images were taken at the distance of approximately 4.0 m from the structure with no angle at nighttime, around 9 P.M. Therefore, the delaminated area should be displayed as a cooler temperature than the surroundings, and every camera indicated the cooler spot at the middle of the structure, even though the parts on the edge of the structure also show cooler temperature values due to the boundary condition.
